CONDITION SURVEY OF APPLICATIONS USING RADCON FORMULA #7

CONDITION SURVEY
OF APPLICATIONS
USING
RADCON FORMULA #7

RADCRETE PACIFIC PTY. LTD.

August 1993

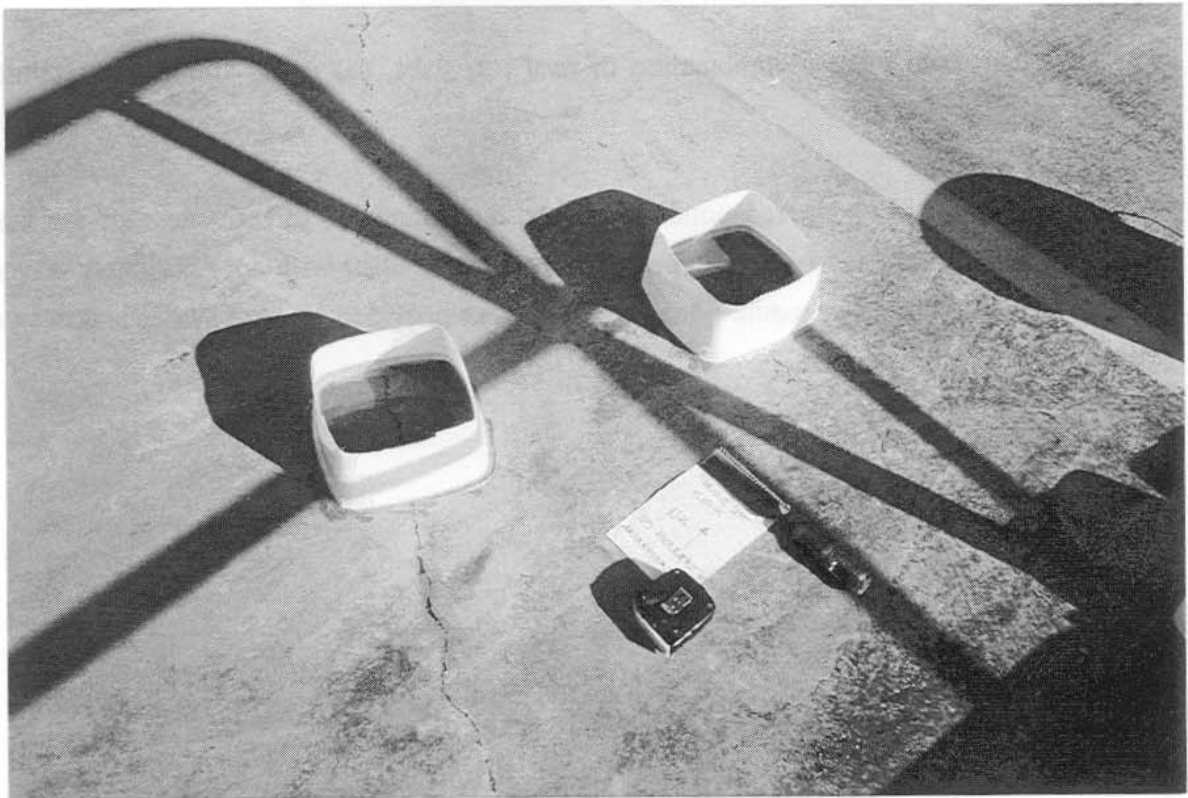
The top level of this car park exhibits severe cracking which extends through the full thickness of the slab. The cracks range in width from hairline up to approximately 1.2 mm. As a result of these cracks, water falling onto the top of the slab would run through the slab. In July 1988 the slab was treated with Radcon Formula #7 to seal these cracks.

As part of our investigation, we conducted ponding experiments to ascertain the effectiveness of the seal. Two cracks approximately 1 mm wide were selected on the top level. The containers, with 40 mm of water in each, were kept in place for 30 minutes to see whether any water would penetrate the slab. No penetration was observed in either location.

Photograph 1: View of filled dams over cracks

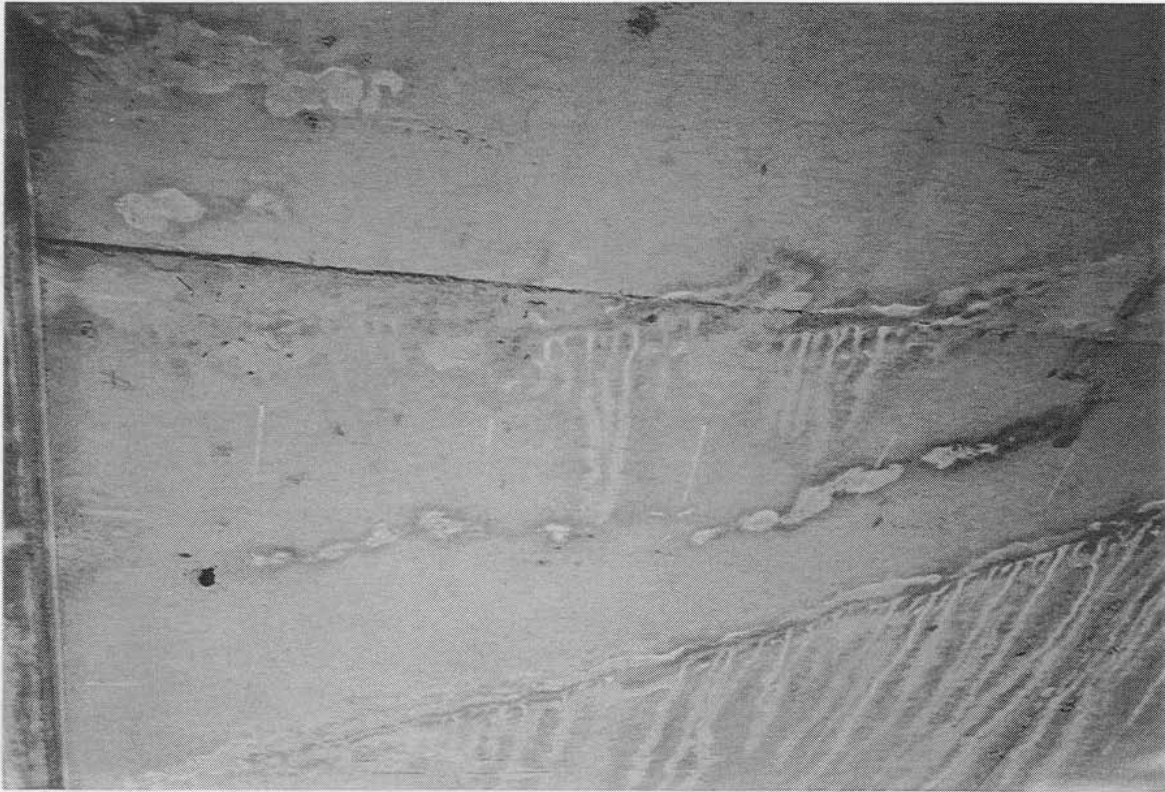
Photograph 2: View of soffit before ponding test

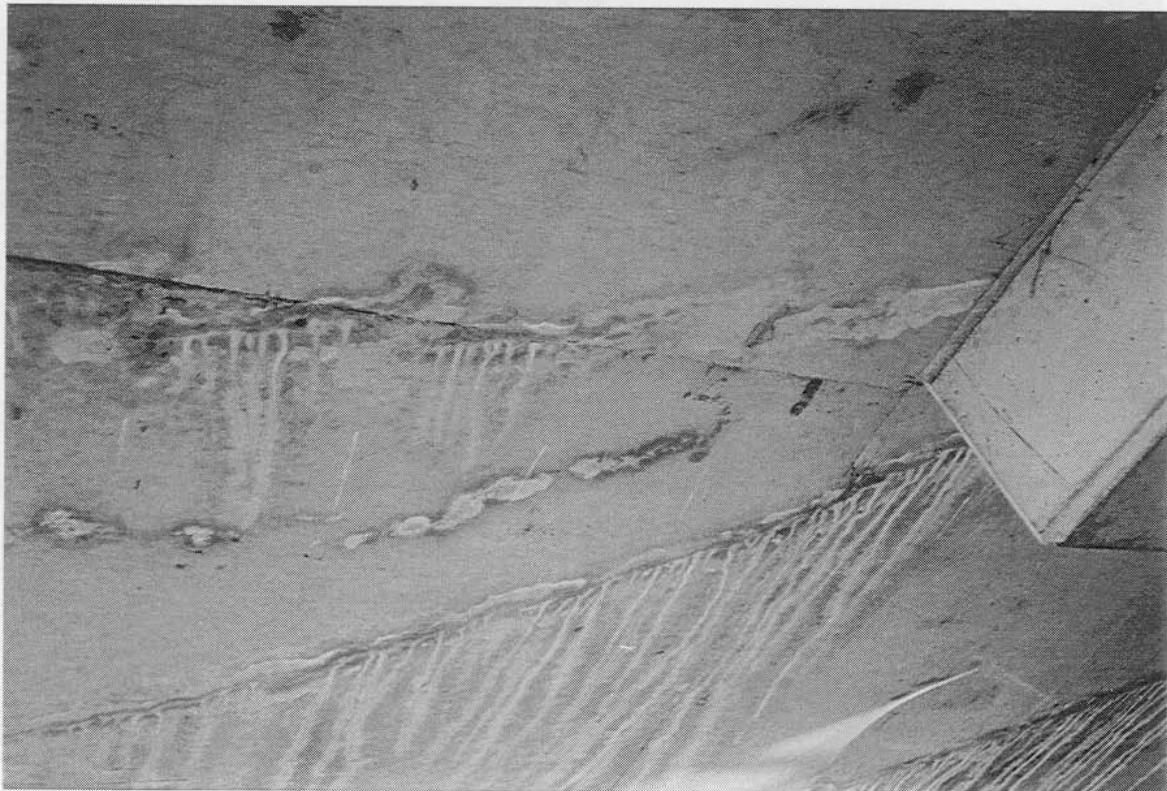
Photograph 6: View of soffit showing mid span crack.
Photograph 3: View of soffit after ponding test, (30 mins)

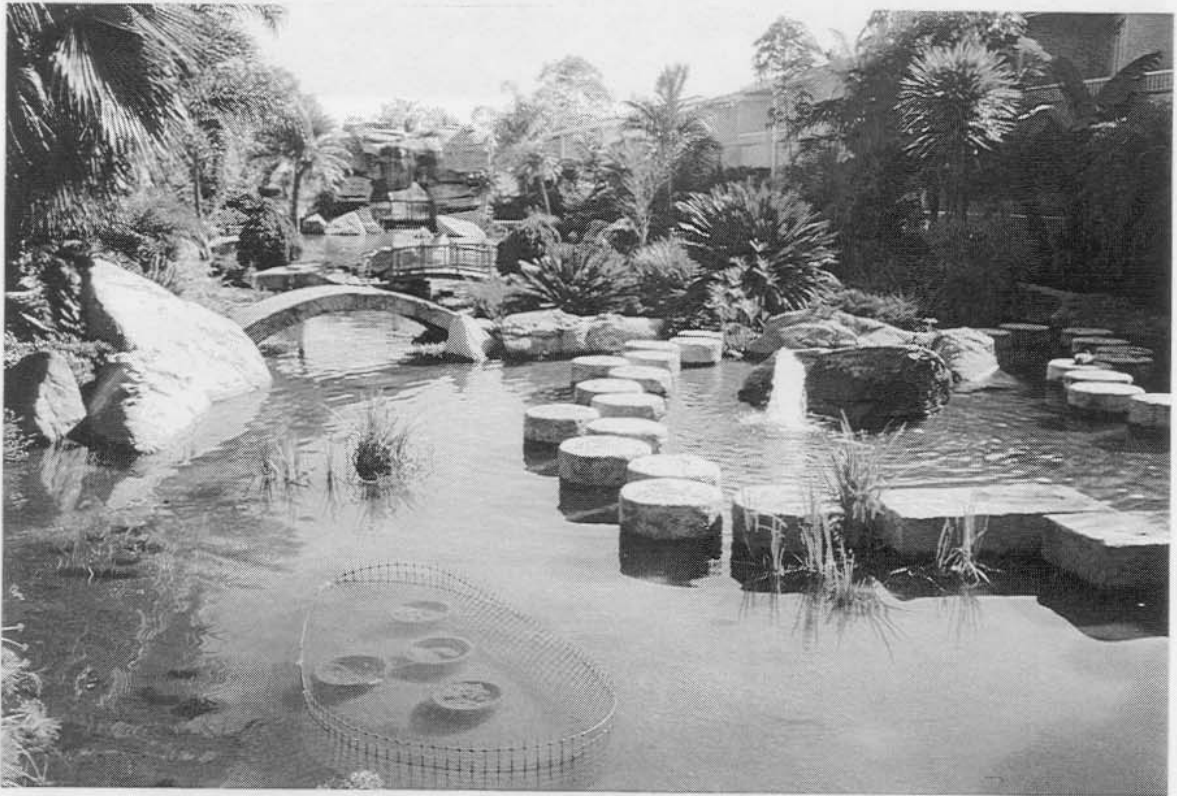
Radcon was used in this application to seal the slab when it was decided to create the lake. The application was carried out in November 1988, after the structure had been in service some years. According to reports, the slab was already cracked at this stage, and it was decided to use Radcon Formula #7 to seal those cracks. Inspection of the slab soffit revealed significant cracking. These areas showed no sign of water penetration. Areas which did show water leaking were along construction joints and joints between concrete and pipework penetrating the slab. The manufacturer does not recommend use of their product to seal these features.

Photograph 4: View across suspended lake

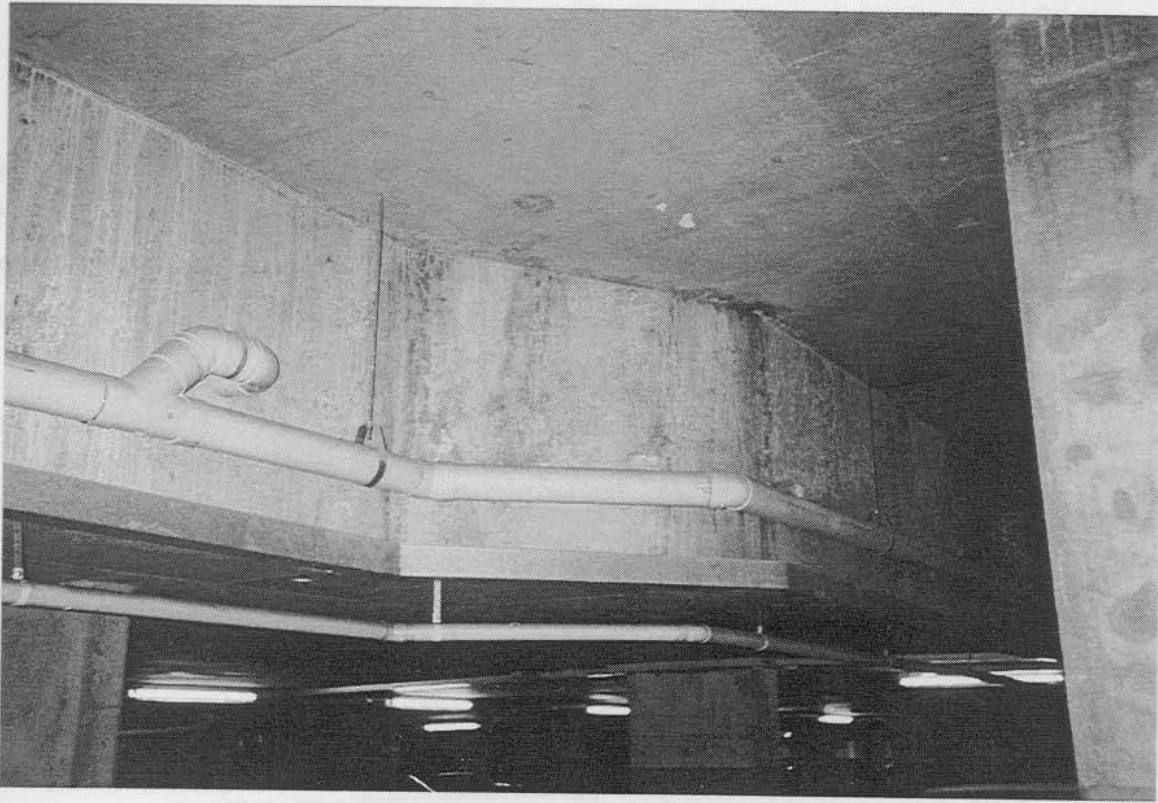
Photograph 5: View of soffit showing sides

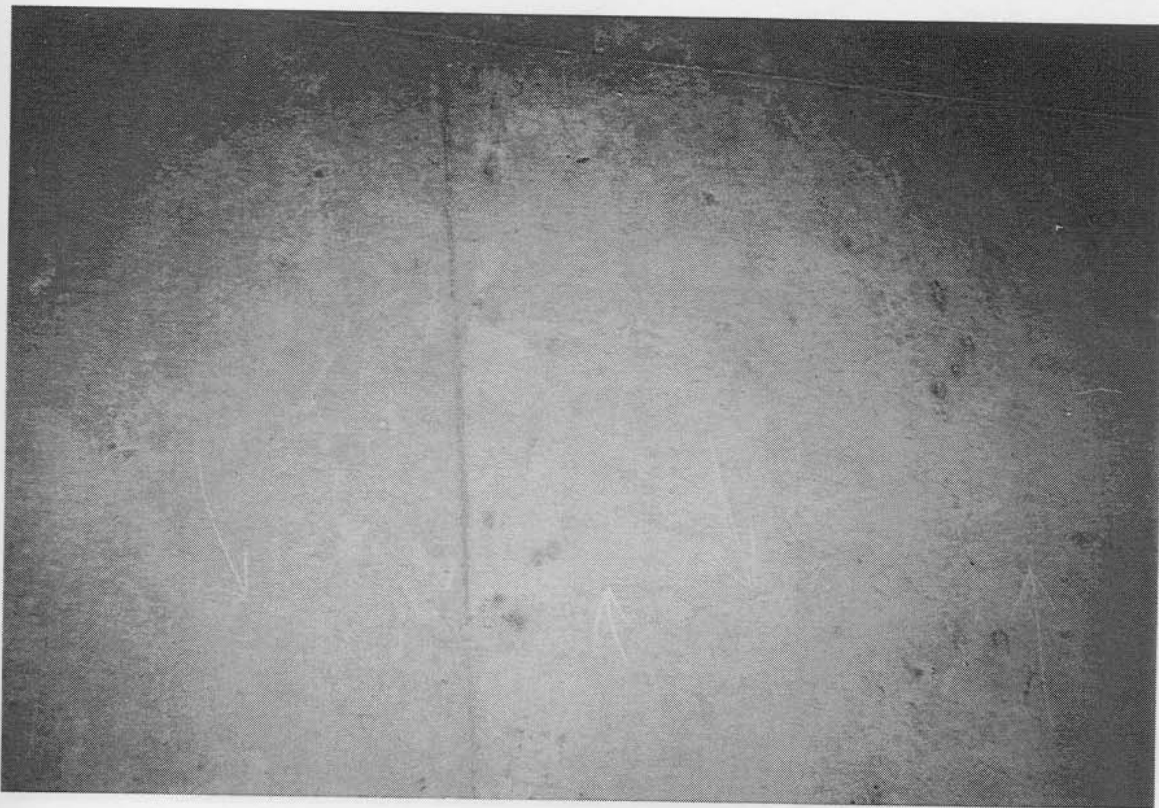
**Photograph 6: View of soffit showing mid span crack,
Note no water marks.**

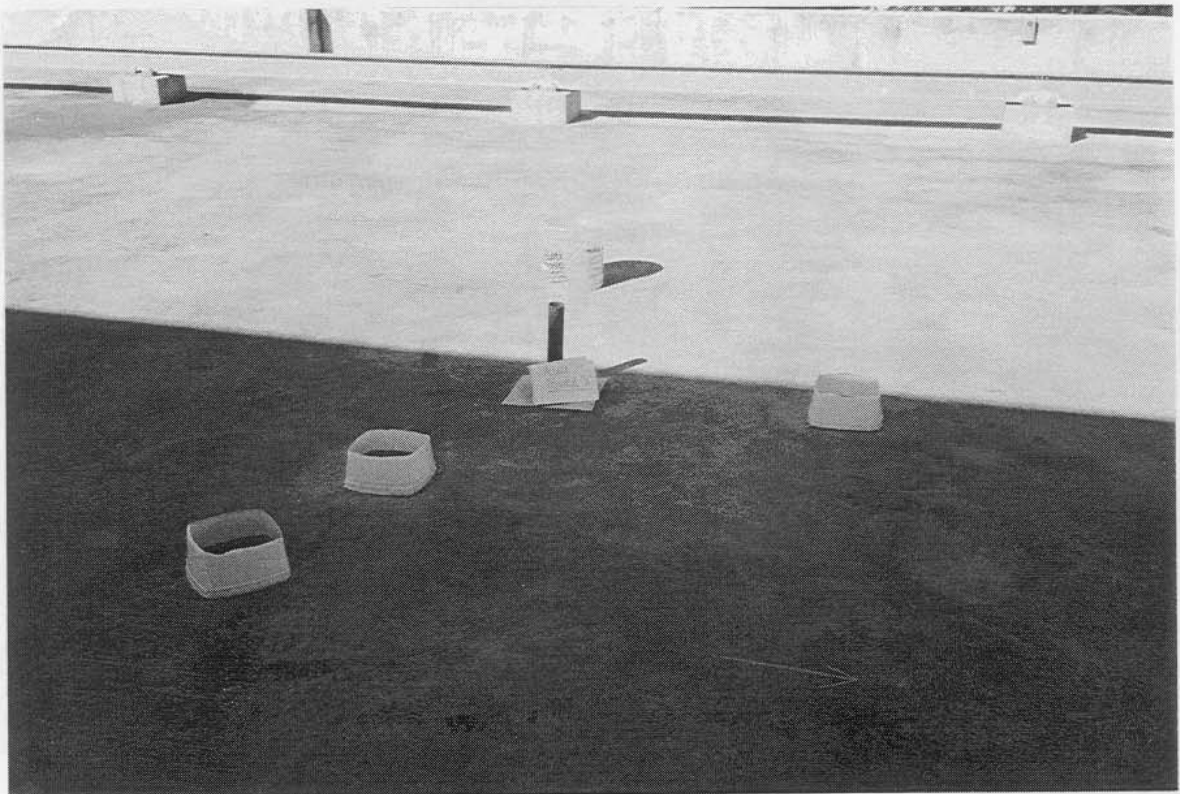
This slab was treated with Radcon Formula #7 during construction in June 1988, after the concrete was completely cured, in an effort to avoid leaking caused by future cracking. A visual inspection of the top revealed some cracking occurred towards the south east corner of the building. Subsequent inspection of the slab soffit in this area showed the cracks extended through the slab. No signs of water penetration were found on the soffit.

Water ponding tests were conducted on these cracks with hydrostatic heads of 40 and 100 mm. No evidence of water penetration on the soffit was noted, further, close inspection of the cracks on either side of the test area showed no leakage of water, indicating that the cracks were well sealed near the surface of the slab.

Photograph 7: View of filled containers over cracks

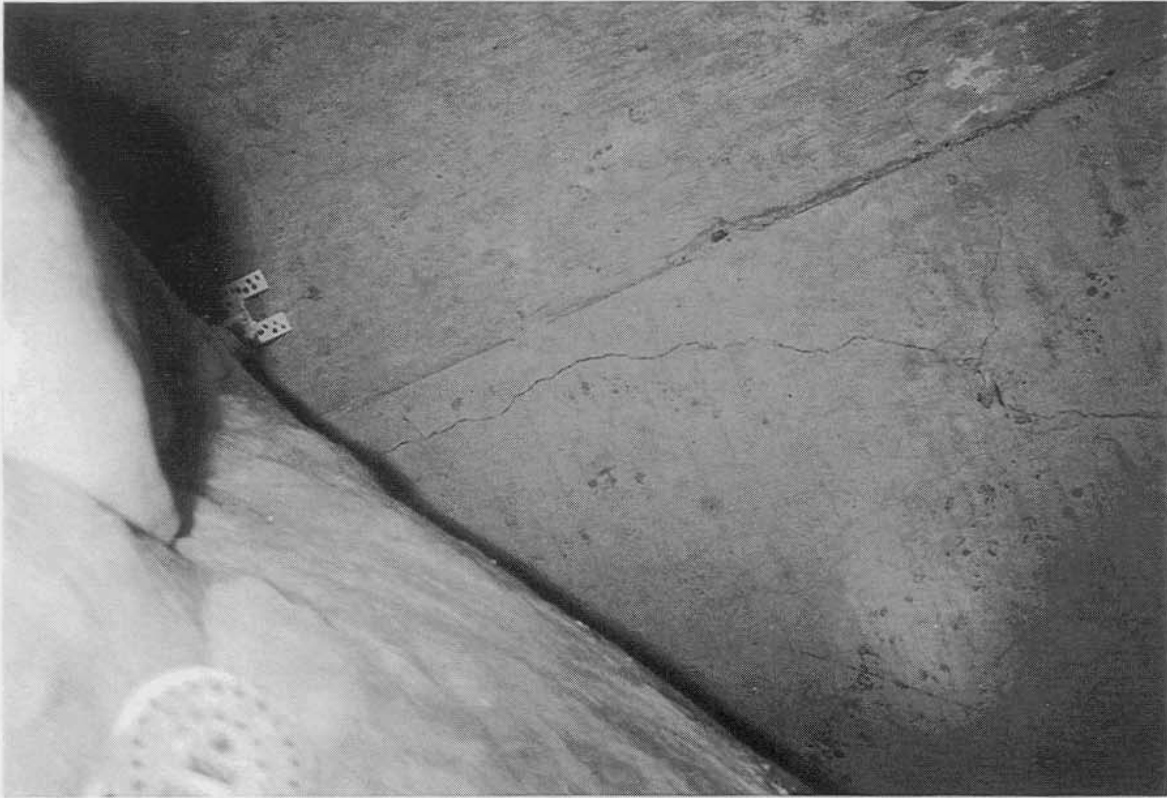
Photograph 8: View of soffit after ponding test, (30 mins)

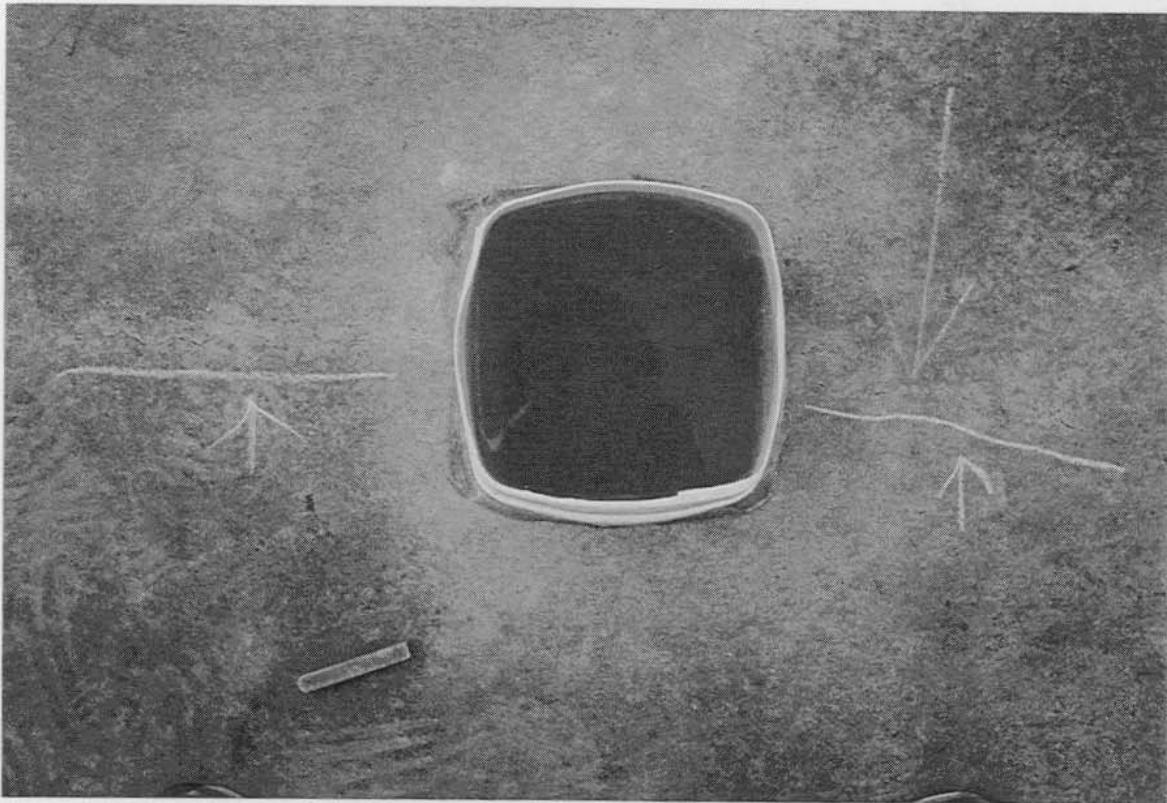
Photograph 9: View of dam after ponding test, (30 mins).

Note no evidence of water seeping along crack.

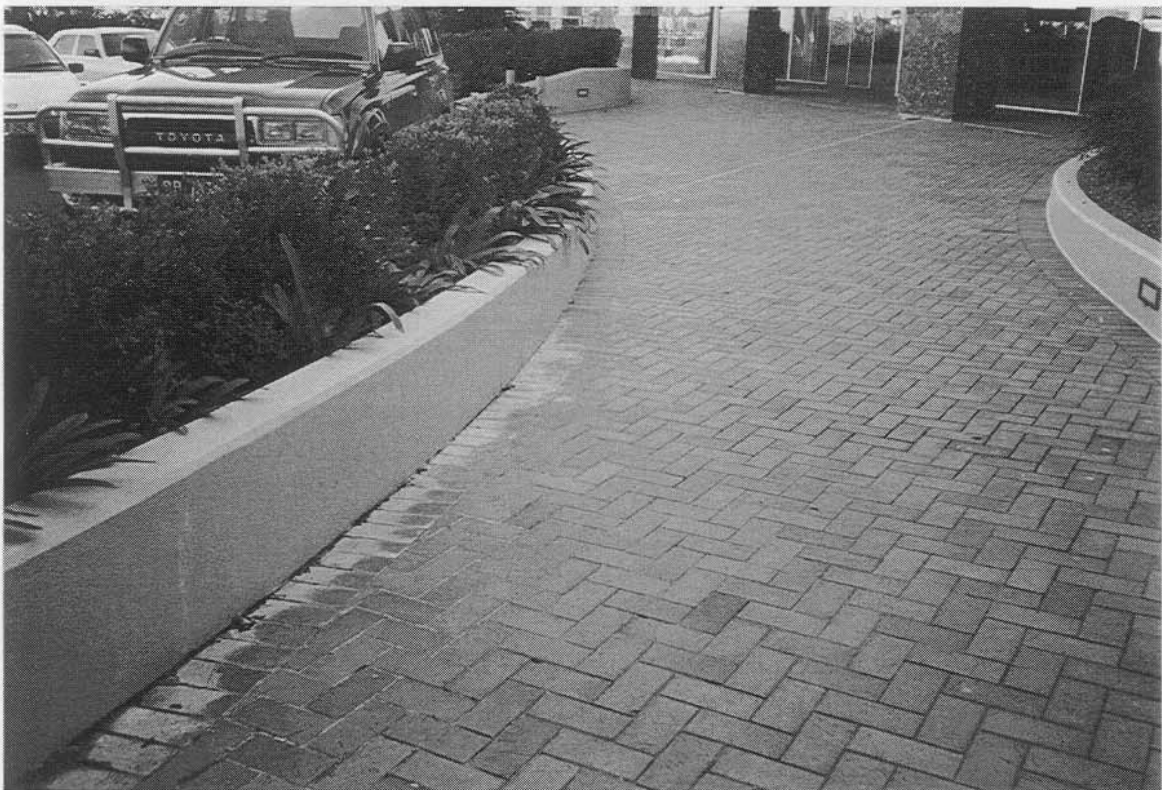
Radcon Formula #7 was applied during construction to stop the penetration of water from external landscaped areas into the car park below. This is an example of an installation carried out without reference to the manufacturer, or the manufacturer's specification and recommendations. The Radcon Formula #7 had been used without appropriate sealing of construction joints, with the result that the joints continued to weep due to the inability of the Radcon to bridge the large voids within.

Photograph 10: View across paved area over car park.

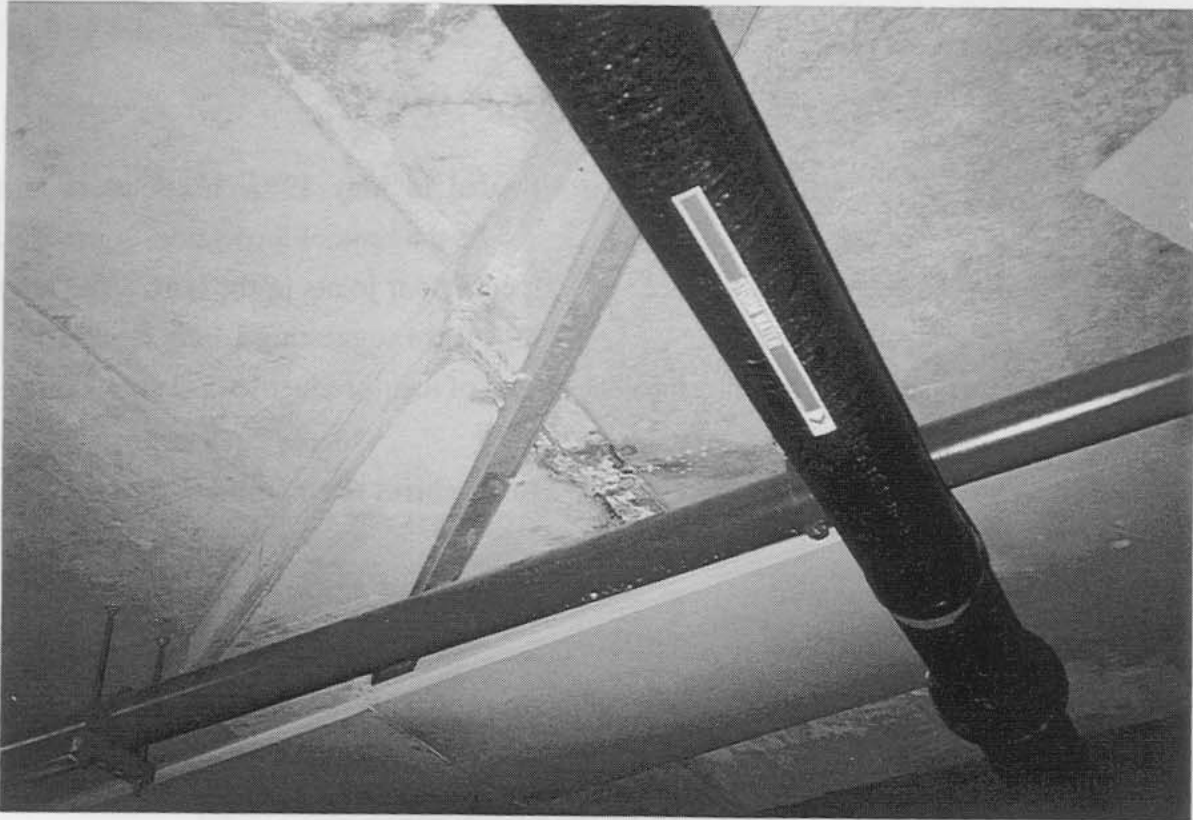
**Photograph 11: View of soffit under paved area.
Note leakage from pour joint.**

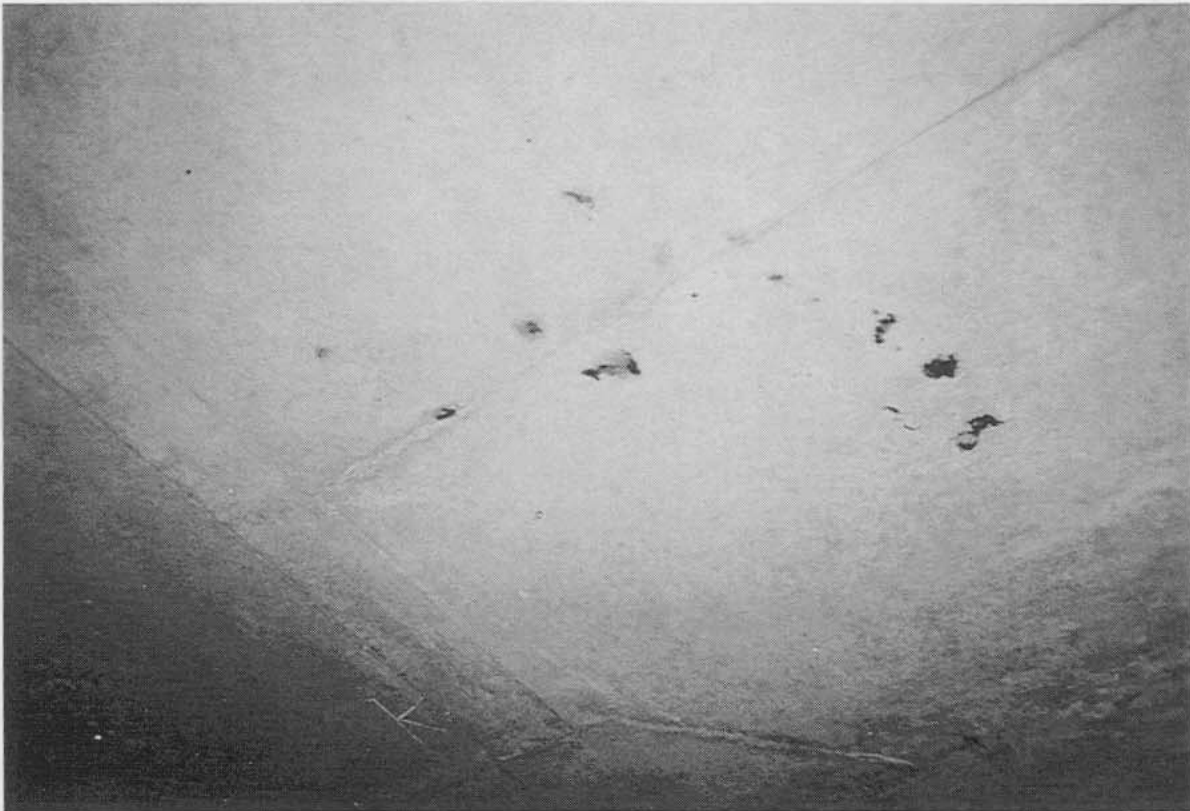
Photograph 12: View of soffit showing dampness in poorly compacted area.

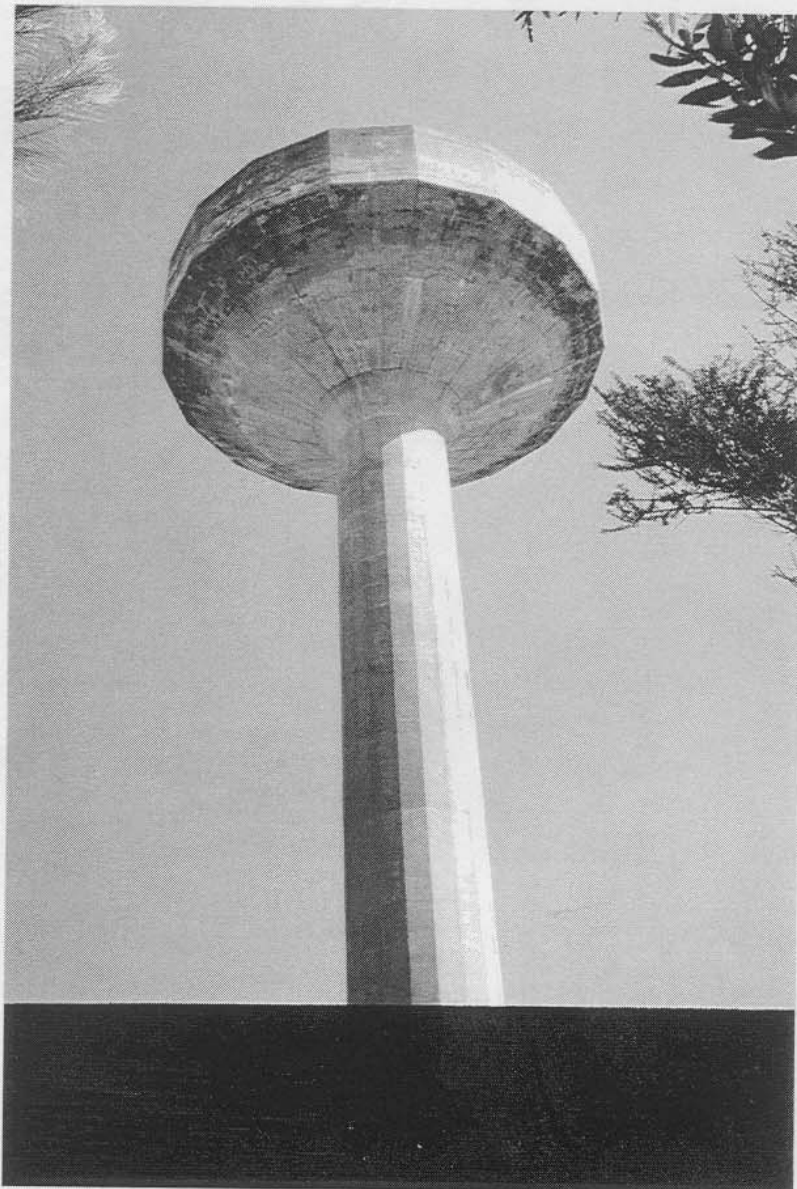
The internal surfaces of the water tank were treated in May 1991, many years after construction, after significant leaks had developed. At the time of inspection, some leaks were noted and were identified as associated with cold pour joints in the tank. The areas noted showed significant calcium leaching around the leaks suggesting a long term leaking problem. The manufacturer does not recommend use of their product to seal cold joints.

Photograph 13: View of tank showing cold joints

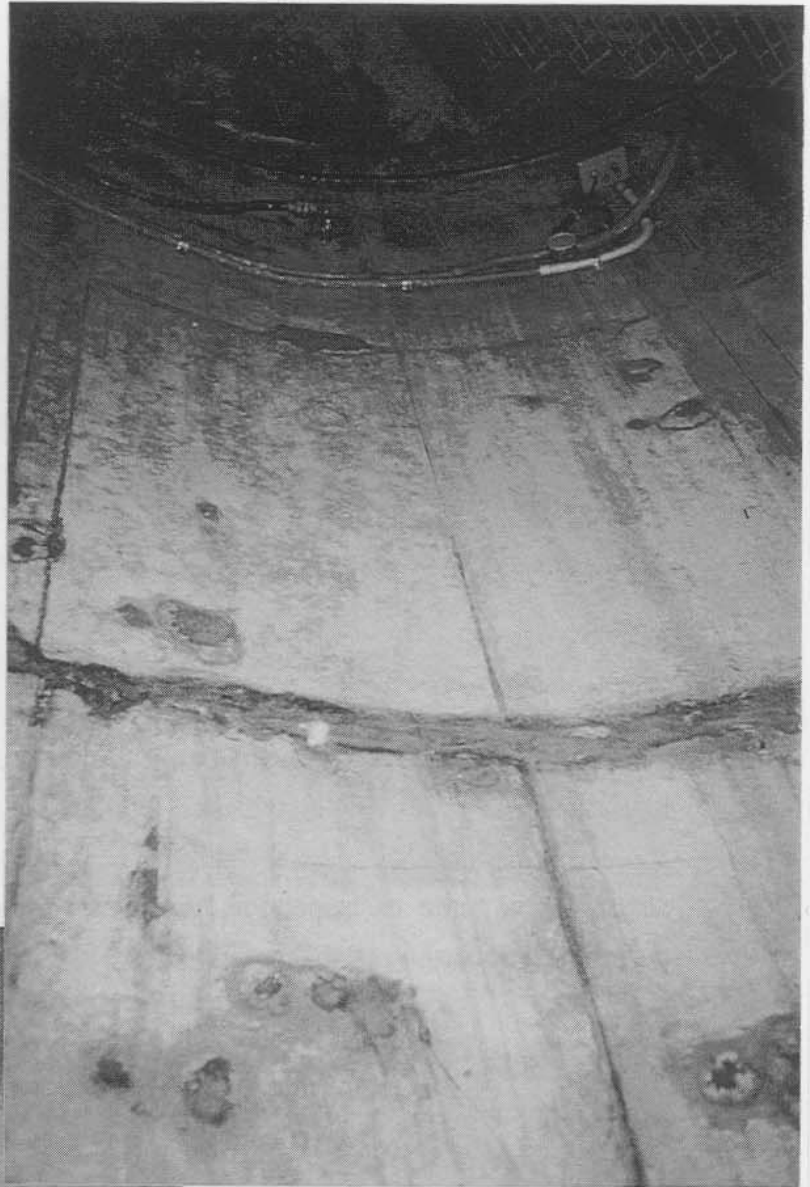
Photograph 14: View of construction joints from inside tower.

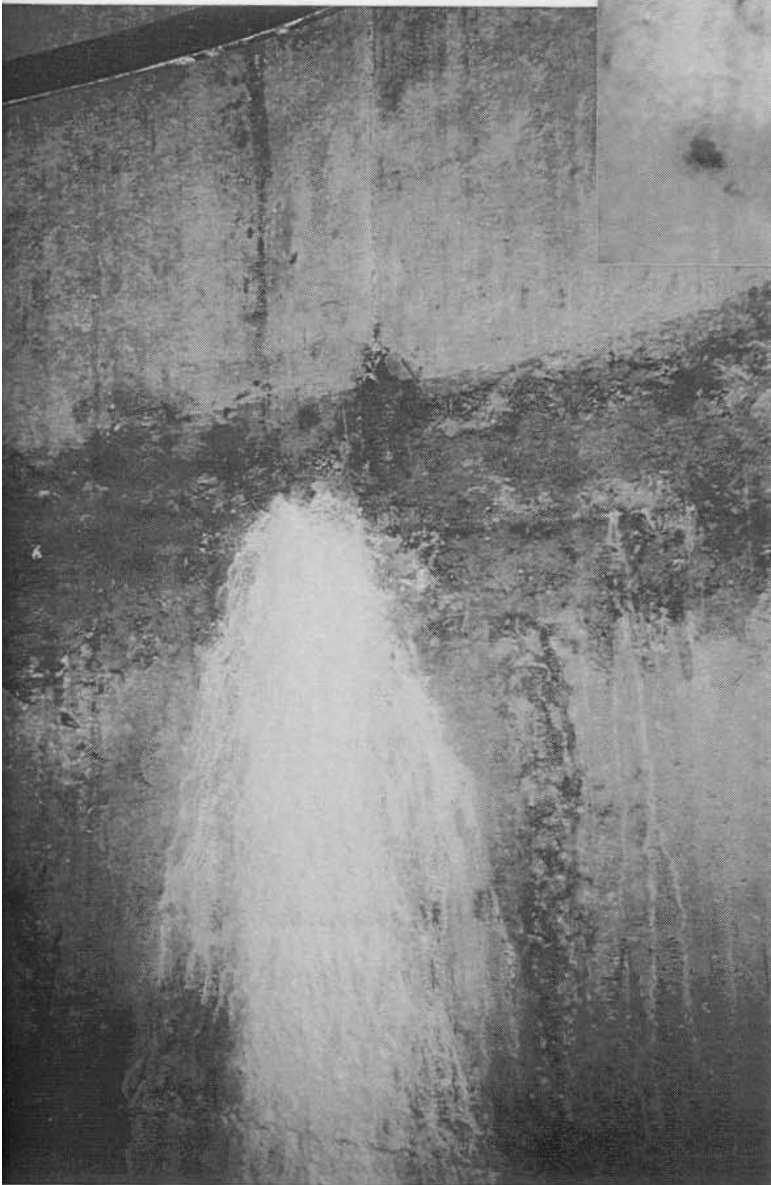
Photograph 15: View of weeping construction joint from inside tower. Note large build up of Calcium deposits.

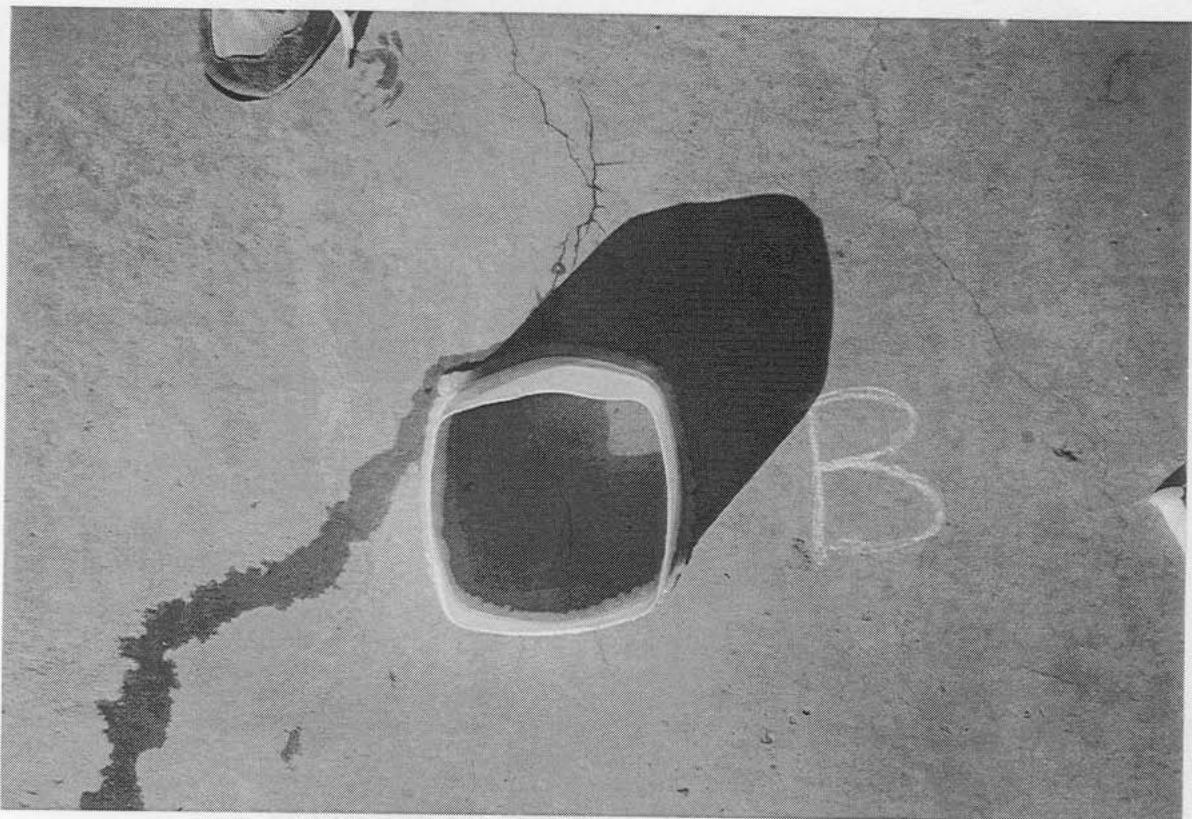
The top surface of this 150 mm thick reinforced concrete slab was treated with Radcon Formula #7 in July 1993. Ponding tests were conducted on two cracks to assess the effectiveness of the treatment. After 30 minutes under a hydrostatic head of 40 mm, no water penetration to the slab soffit was noted. However, water was seen tracking along the cracks on the top of the slab. This was not seen on other ponding tests and Mr Tony Hilder of Radcrete Pacific stated that this is believed to be due to the short time since placement allowing insufficient time for adequate growth of the material to take place, and, given sufficient incidence of wetting, this growth will take place within a few months, filling the crack to the surface.

One issue of concern was the high deflections noted on the slab, especially due to moving loads such as cars driving in and out. These high dynamic loads may cause cracking of the Radcon in the existing cracks, requiring recrystallisation. However, given the movements noted at the time of inspection, the Radcon was effective in sealing the cracks and performing according to the manufacturer's claims.

**Photograph 16: View of dam during ponding test, (30 mins).
Note water tracking along crack.**

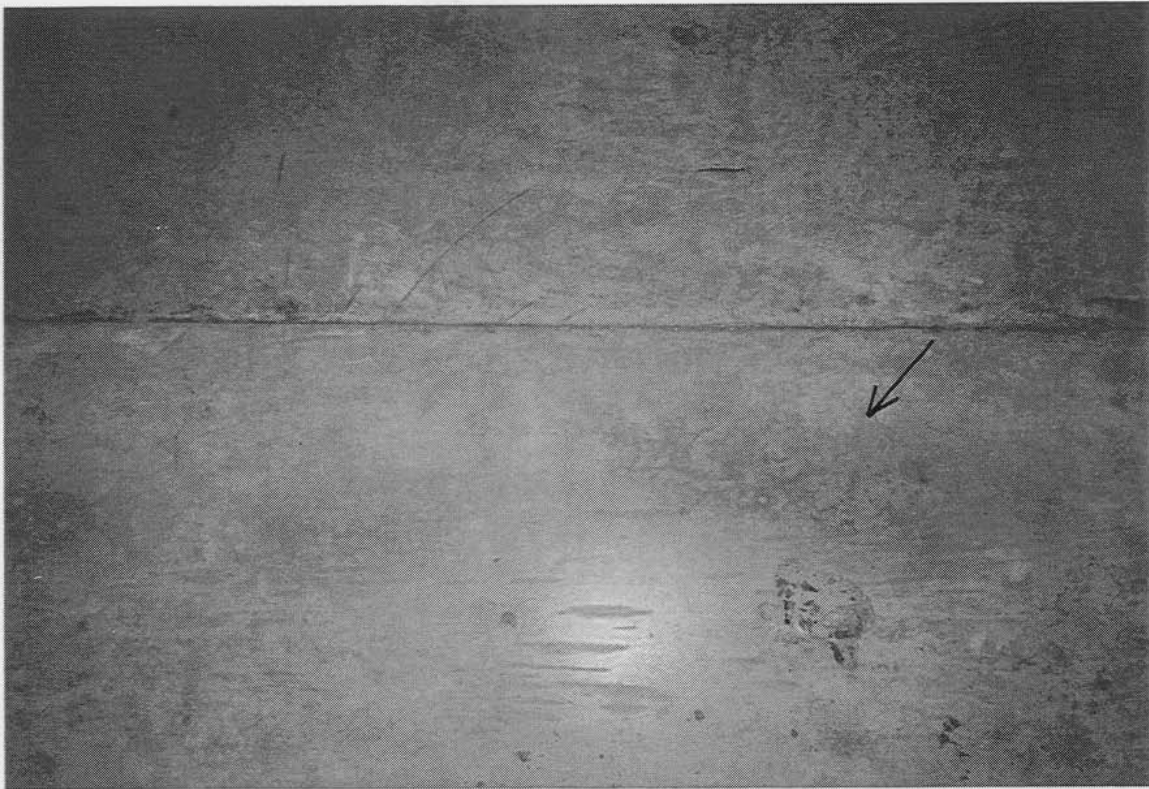
Photograph 17: View of soffit under pond before test.

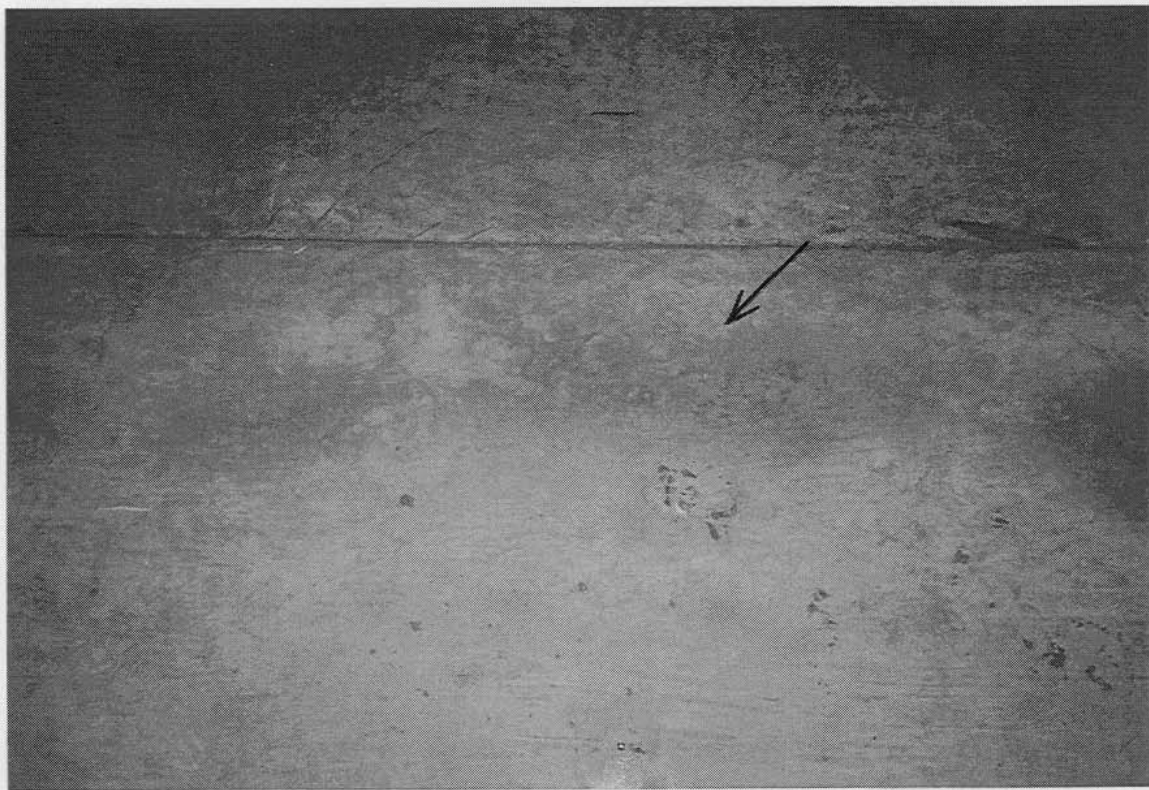
**Photograph 18: View of soffit after test, (30 minutes).
Note no evidence of water penetration.**

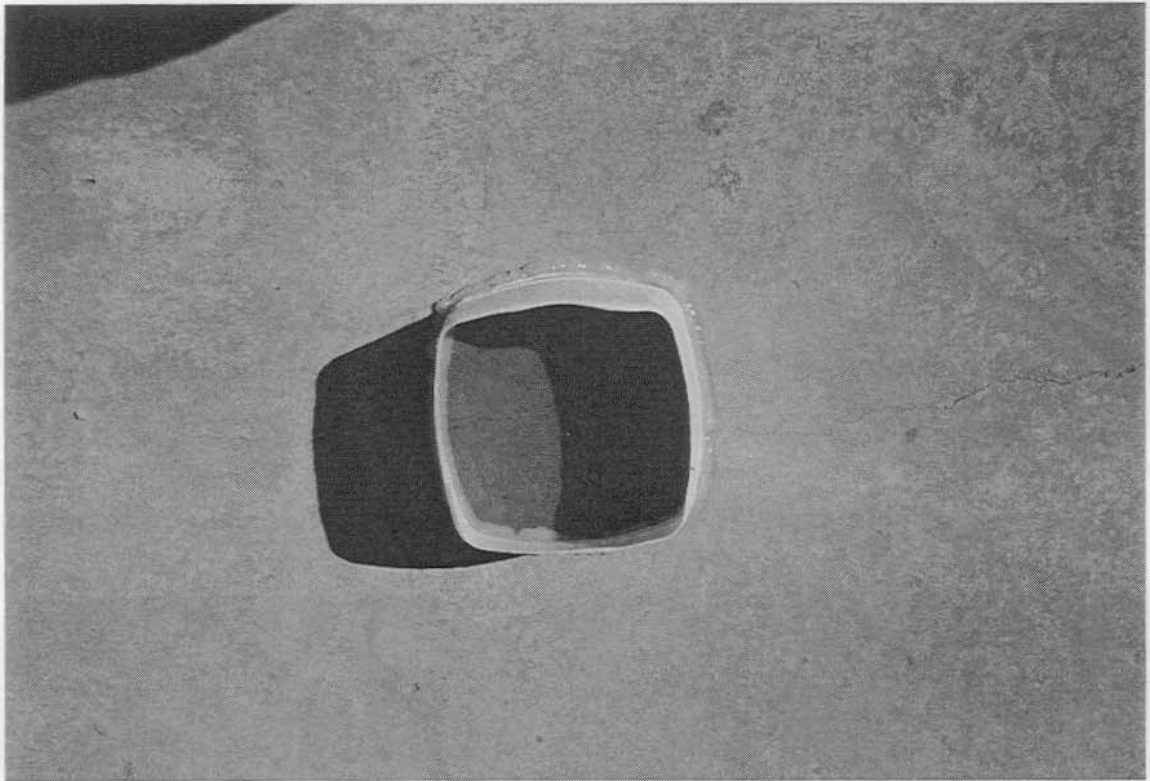
This application was placed in May 1993. Ponding tests on the slab showed no water penetration after 50 mm of hydrostatic head was applied for a period of 30 minutes. It is interesting to note that no tracking of water was observed on the top surface of the cracks.

Photograph 19: View of dam after ponding test, (30 mins).

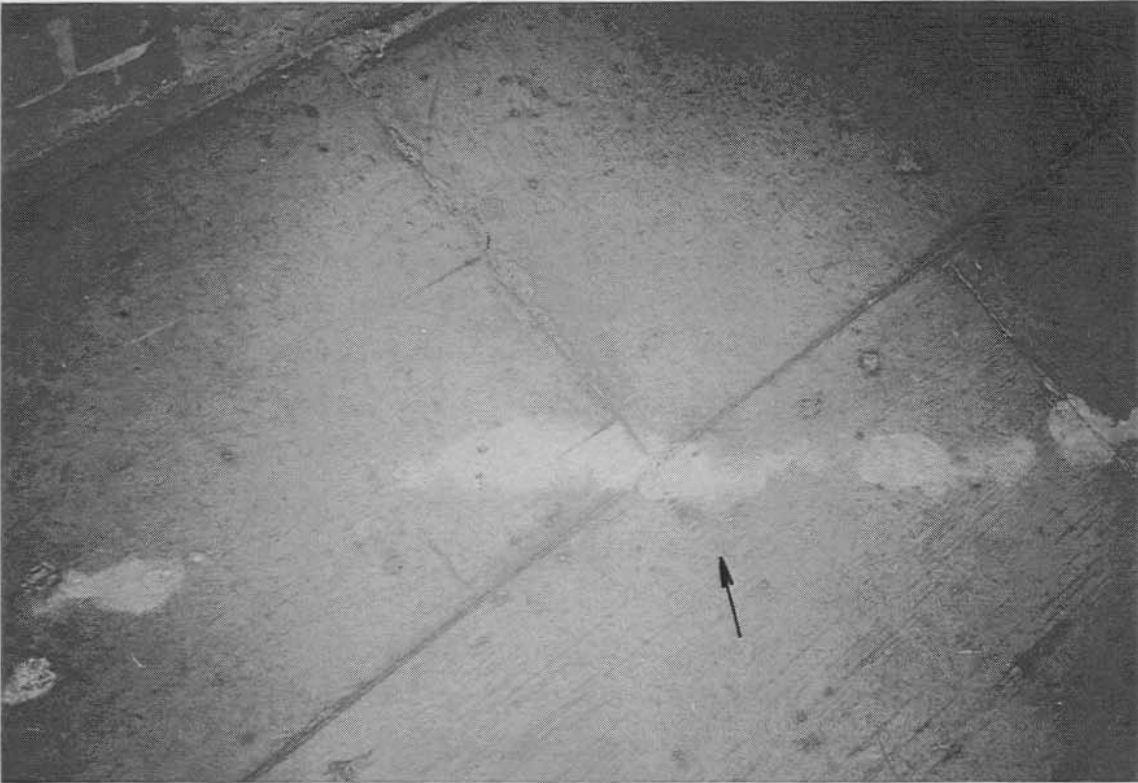
Photograph 20: View of soffit under pond before test.

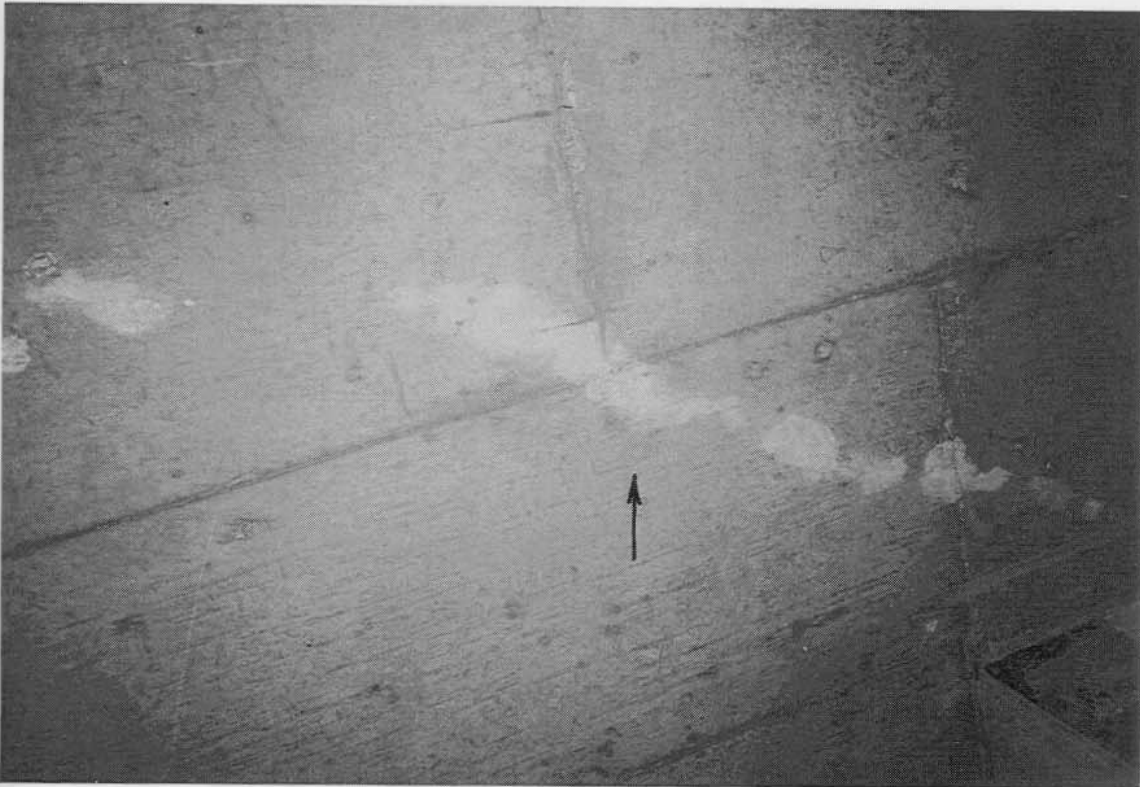
**Photograph 21: View of soffit after test, (30 minutes).
Note no evidence of water penetration.**
