# **RADCON<sup>®</sup>**

## **FORMULA #7**

ABILITY OF RADCON #7 TO MAINTAIN A  
WATERTIGHT SEAL ON CRACKS FOR A FULL THERMAL CYCLE

*16-18 March 1995*

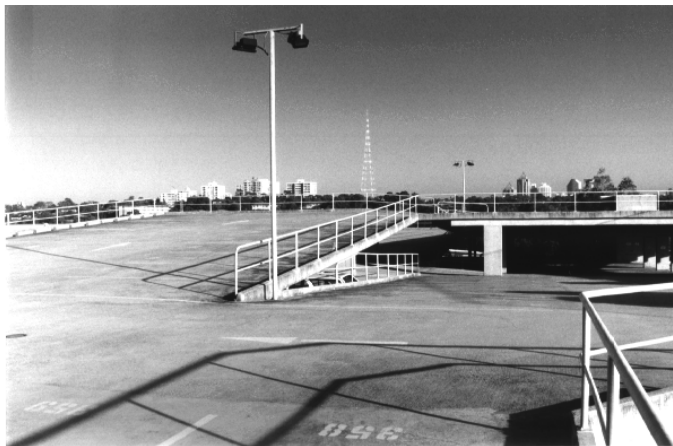
## TOP CAR PARK DECK

Site Notes: This site is a four level car park with normally reinforced decks. It was Radcon #7's first major car park sealing job undertaken with severe leakage evident. A total of 300 lineal metres of leaking crack ranging from 0.5 - 2.5mm in width were evident prior to treatment.

Radcon #7 was treated to the entire top level which is completely exposed. The treatment was a complete success, however some major cracks required two or three treatments to gain a 100% seal. These re-treated cracks obviously contained large voids which required additional product to bridge the cracks entirely.

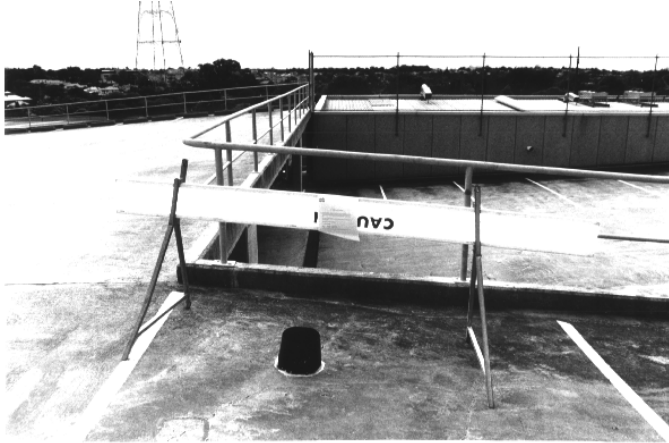
#### Location Shot ~ Crack #1

This crack is located on the top deck of the car park that is exposed to the weather. It was treated with Radcon #7 and has maintained a seal since the application in 1988.

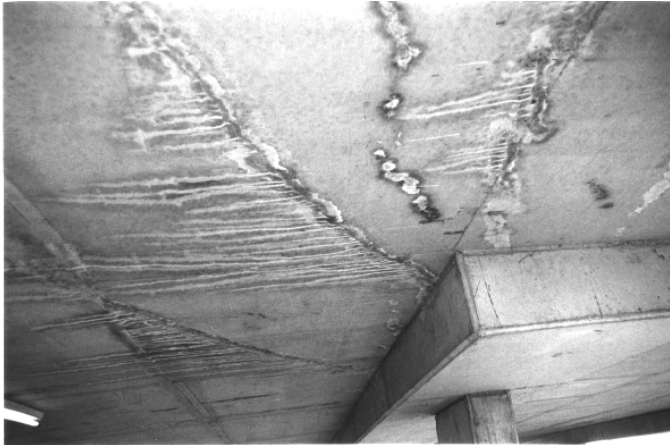
Underside ~ Crack #1

It should be noted that the site had been leaking for a period of approximately 9 months prior to the Radcon #7 application. This is the reason for the extensive calcium leaching (staining) on the underside of the slab.

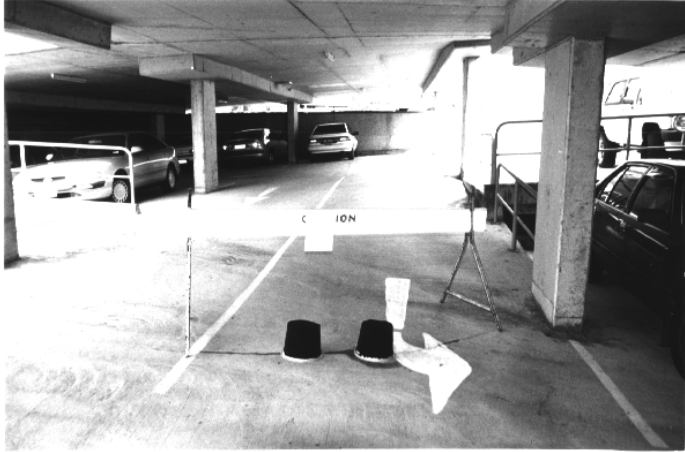
#### Location Shot ~ Crack 2

This crack is located on a lower level that is exposed to wind-driven rain and leaks during raining periods. No attempt has been made to waterproof this crack.

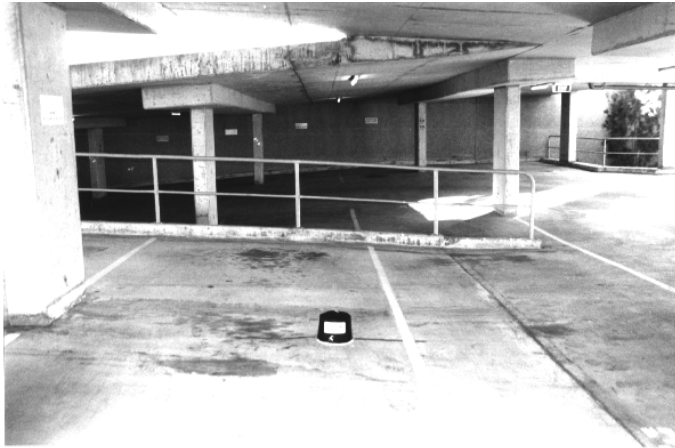
#### Location Shot ~ Crack #3

This crack is located on a lower level that is exposed to wind-driven rain and leaks during raining periods. No attempt has been made to waterproof this crack.
