# TECHNICAL ARTICLE

## **Radcon Formula #7 - the only waterproofing solution**

Waterproofing of the State Prison rooftop in Minkovice - Czech Republic wasn't an easy task.

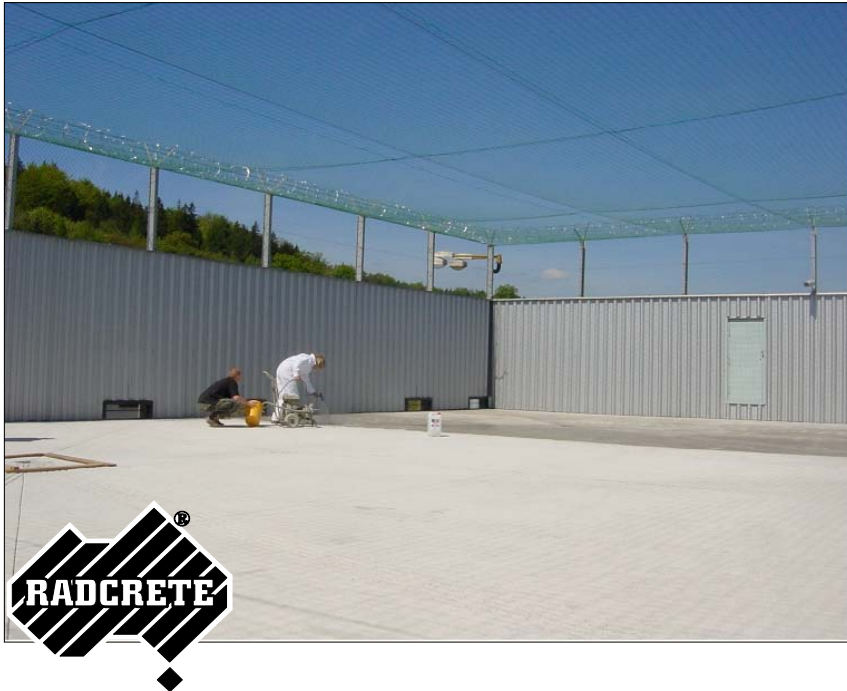
**FIGURE 1**  
Radcon Formula #7 application onto a rooftop area of the State Prison in Czech Republic.

The area has been previously treated with various waterproofing and water repellent products without success.

Firstly, the structure could not hold additional weight load, such as concrete topping required when using traditional bituminous membranes.

Secondly, there was a ponding problem, most likely responsible for hasty failures of the previous waterproofing solutions.

Radcon's waterproofing performance was proven shortly after application by a successful pond test and this "problematic" area became yet another lifetime concrete waterproofing reference in Czech Republic.

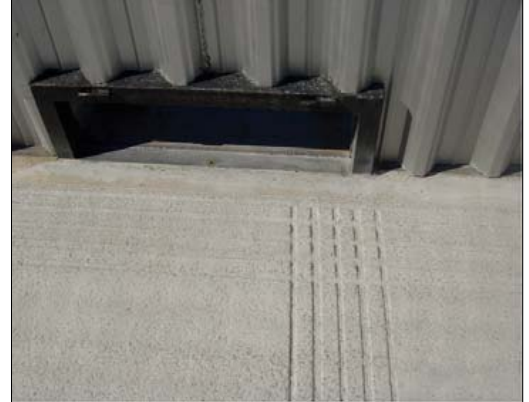
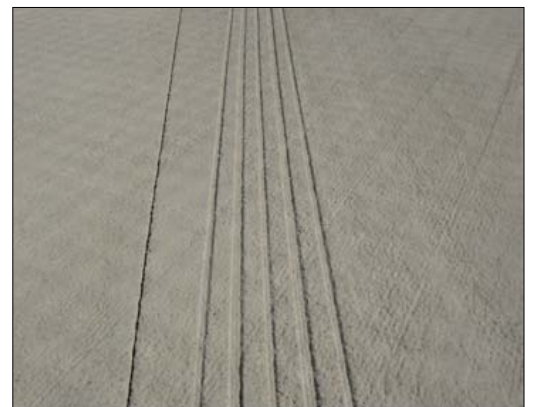
**FIGURE 2 & 3**  
Grooved rooftop surface - drainage solution

The rooftop was first grooved to ensure a fall line which may drain any excess water (as shown in figure 2 & 3) then Radcon Formula #7 was spray-applied to the exposed area.

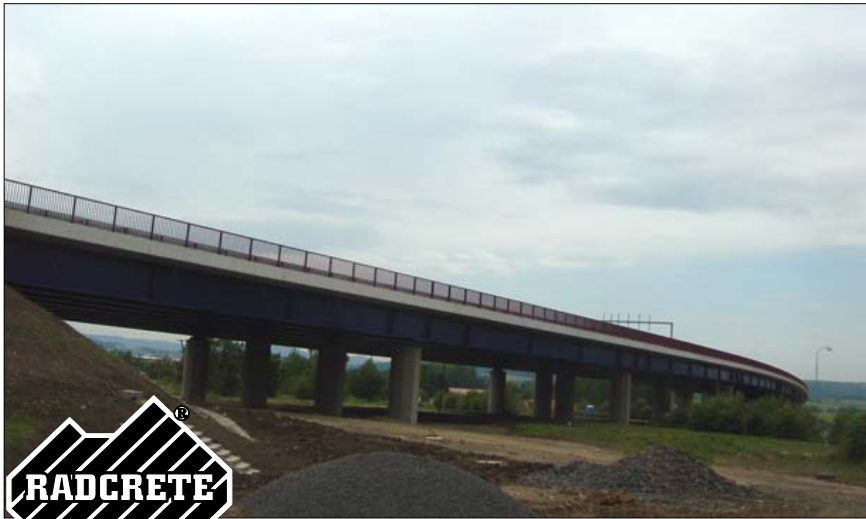
**FIGURE 4.**  
Bridge in Ostrov - Czech Republic.

Prior to it's opening it was rejected by the client - the Department of Transport Czech Republic, due to new cracks appearing around the drainage areas.

Petr deployed customised application of Radcon Formula #7 - a "brush injection" and achieved the desired 100% watertight result.

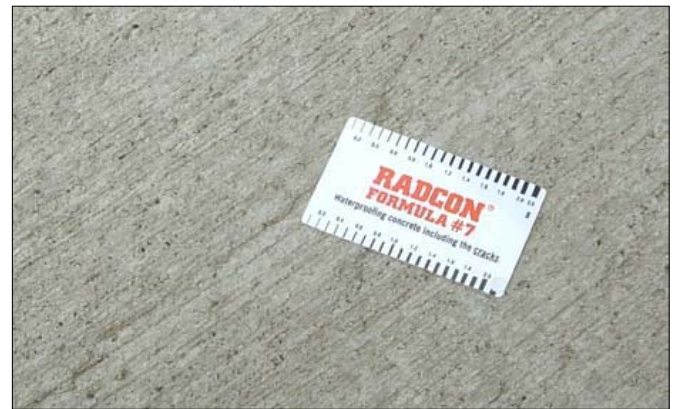
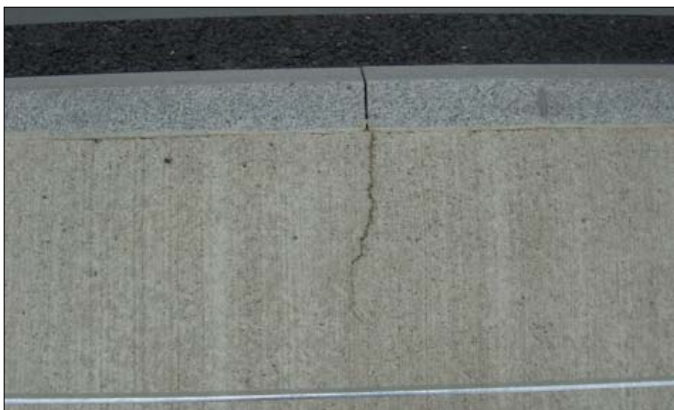
From the photos of the bridge application there is no evidence of these 2.00 mm cracks referred to although I have no doubts they existed.

With cracks of this size, to my mind certain areas of the bridge must be settling.

This settlement may be complete or continue, causing 2.00 mm cracks to open further beyond Radcon's ability to re-seal, lets hope not.

**FIGURE 5 & 6**  
Cracks on the drainage areas
