# BRIDGE DECK WATERPROOFING — A NEW DIRECTION

MY THUAN BRIDGE — MEKONG RIVER, VIETNAM

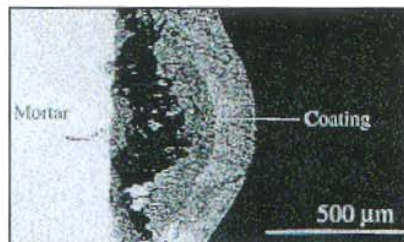
SEM MICROGRAPH SHOWING A BLISTER IN A POLYURETHANE MEMBRANE

- The membrane, which exhibited excellent adhesion to concrete and asphalt in the laboratory, is found to be bubbling up and failing on site.

- The failure is not a product or application-detailing problem - the membrane was applied to a concrete surface that contained entrapped moisture.

A perfectly sealed membrane is not a breathing surface and so, as the heat from the sun drew vapour to the top of the slab (in effect, sweating), the membrane has been blown off to the point of delamination.
